Tumut Management Area Fire Salvage

2019–20

Final Report (*for public release*)

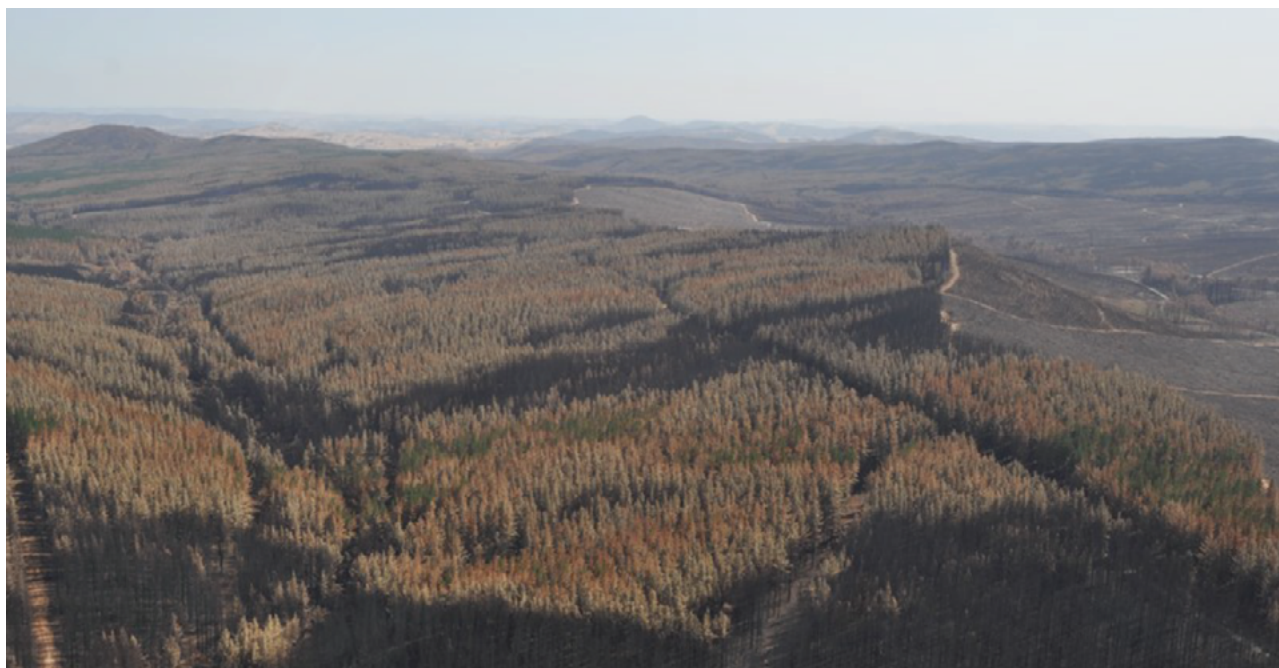
Photo 2-1: Green Hills North demonstrating minor areas of green crowns (Photo G. Jeffries 24/1/2020)

Note: The minor green crowns in this image are not apparent in an NBR analysis as the scattering of dead trees and dead lower canopies influence the result.

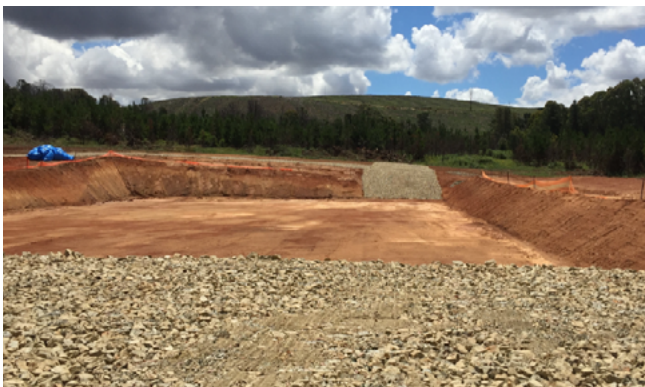
Earthworks

1. Site surveyed and designed by GeoTrack Engineering and constructed by Brennan's Earthmoving.
2. Construction of a 1.5m bund (wall) around storage cell approx. 0.4ha in size with opening for machines to start stack construction. The trial site required some cut and fill. A Blowering site would be effectively flat.
3. Rock was laid at the dam entrance to ensure stability of the bank.

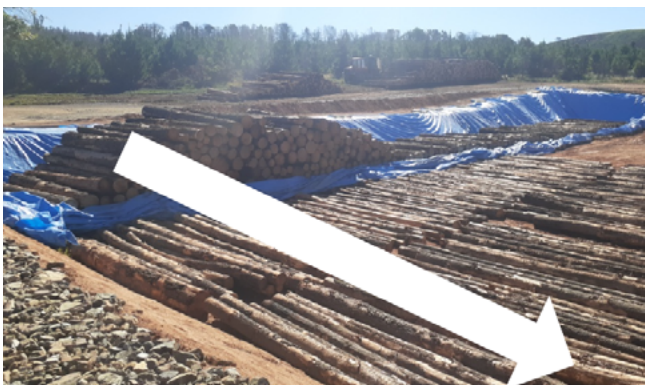
4. The bottom of dam lined with log corduroy to ensure firm footing for machine operation and minimise depression of logs onto dam liner
5. Dam liner placed on top of log corduroy –single row width to enable machine to construct row of logs without damaging liner
6. Liner rolled out underneath next row and welded as necessary to seal dam

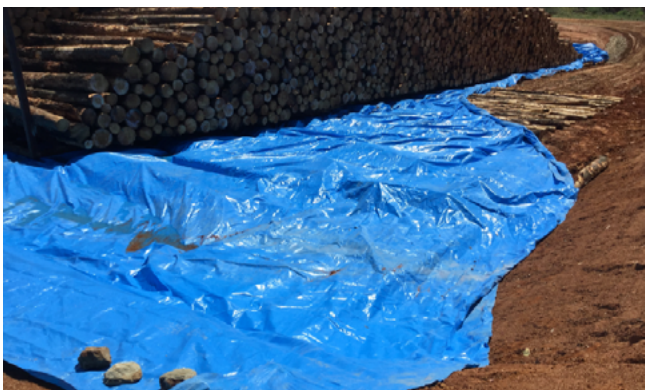
7. Log stacks built by forwarder or excavator to approx. 4m high on top of liner (stacks at least 6m high would be preferred)
8. Bearers may assist with minimising damage to liner and in recovering logs. Ideally recovery of the liner would be anticipated to enable it to be utilised for other purposes (however the trial provided that substantial damage to the liner can be expected during decommissioning).

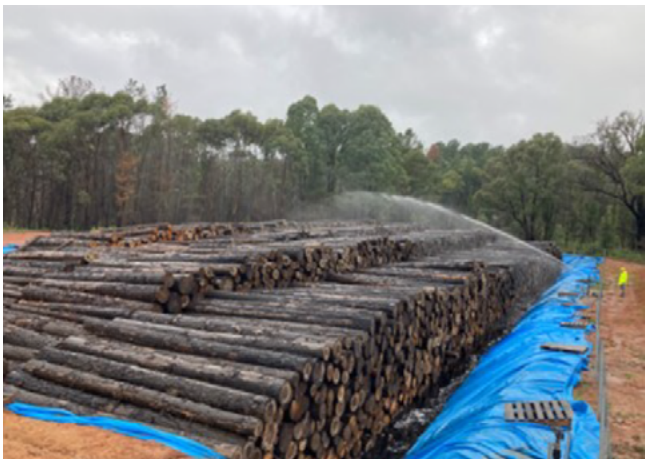
9. Installation of pipework and sprinkler system by Randall Irrigation in accordance with a design by Waterwise Consulting
10. Irrigation infrastructure was installed around the perimeter of each cell
11. Raw water introduced into the dam from Germans Creek
12. The dam was be filled to approx. 1.5m to ensure adequate recharge depth was available for pumps to draw on.
13. Irrigating of stored logs with a target application of 100mm per day, with main pump system drawing water from the dam system, which was independently topped up from the creek, as required.

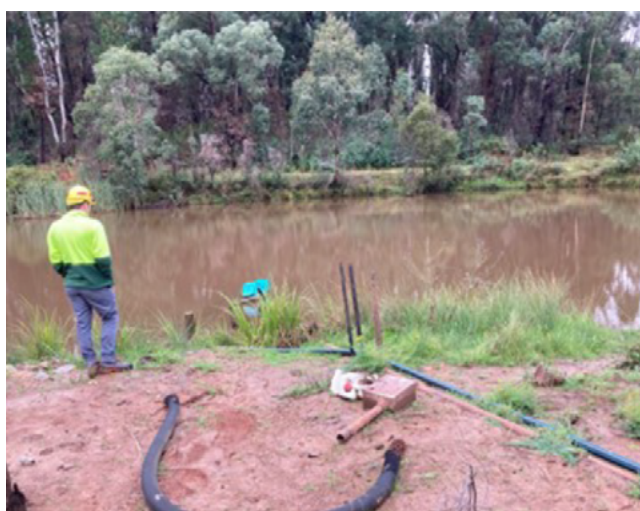
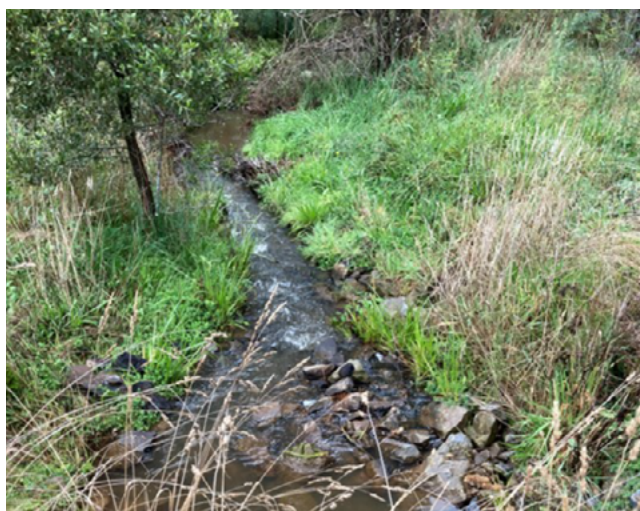
Photo 6-1: Water source on Germans Creek and overflow of water source

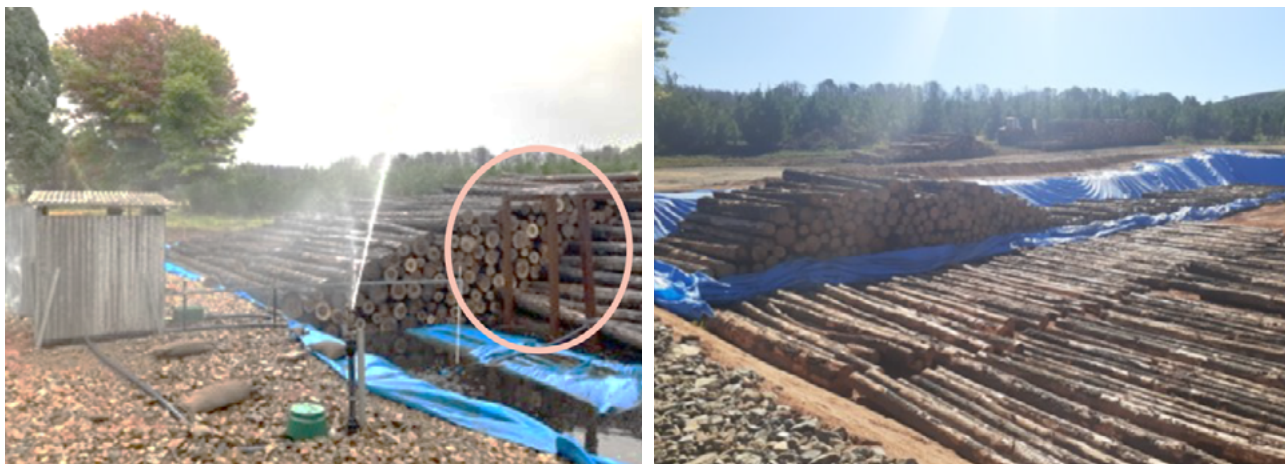
In order to safely stack logs in a confined space to over four metres, the use of steel bookends was essential. For the trial they were utilised to test how placement of them would impact the liner and other logistics. Whilst driven poles are often utilised in the industry, as a cheaper alternative, it was not practical when a liner would be in use.

Photo 6-2: Bookend placed in dam, first row of stack and corduroy underneath

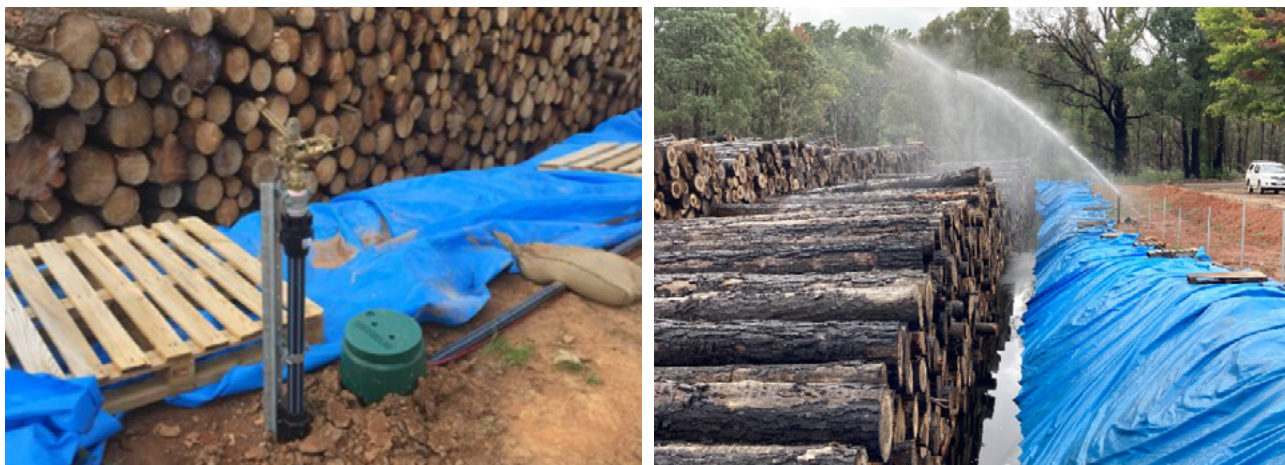
Photo 6-3: Photos showing the irrigation system and log watering

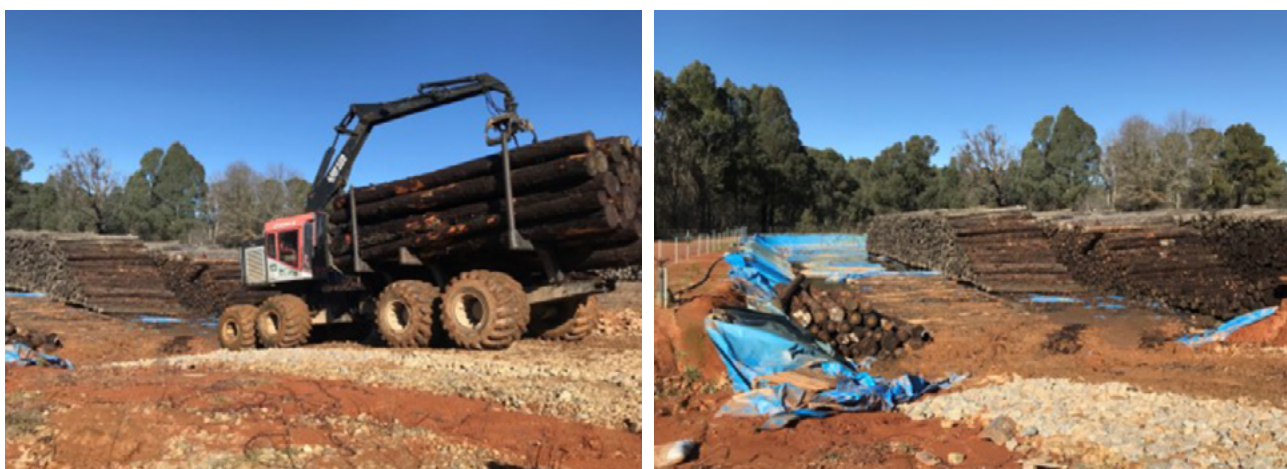
The storage dam was decommissioned in late July 2022. Initially all logs near the top of each stack were set aside as they clearly had received less consistent water and contained higher levels of blue stain. The remaining logs were seen to still be very wet, and for the bottom third of each stack were essentially still sitting in water.

Photo 6-4: Logs being removed from the storage dam July 2022

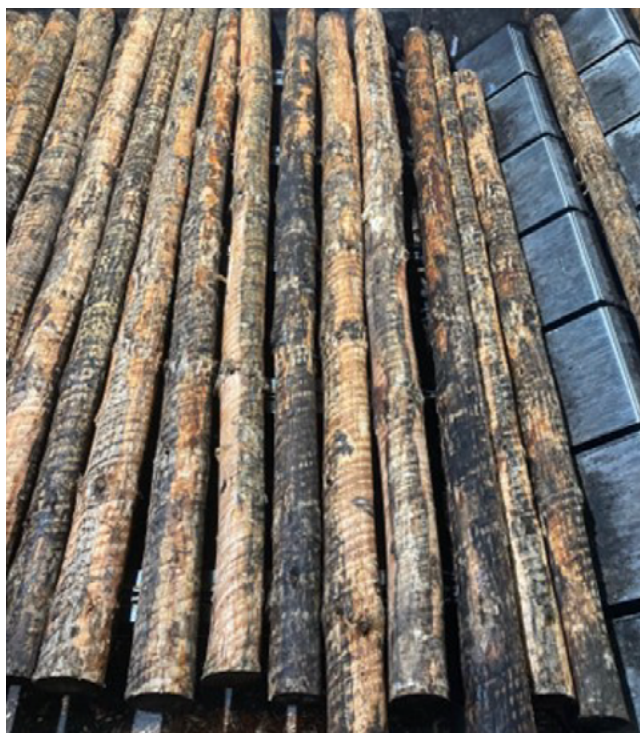
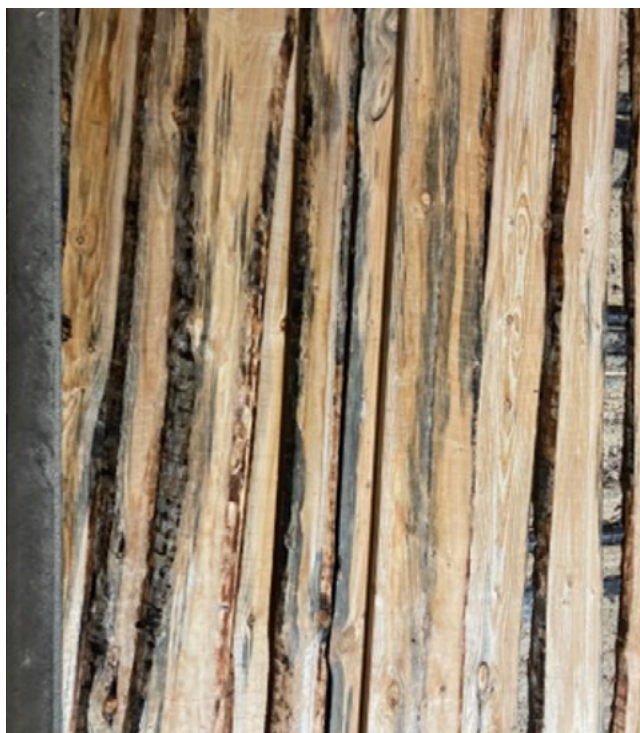
Significant blue stain was evident; however it was observed that it was no more severe than logs typically processed from the general salvage operation through 2020 and 2021. Given the logs probably contained high levels of blue stain at the beginning of the trial, the watering process was reasonably effective in mitigating any further deterioration.

Photo 6-5: Photos of trial logs prior to and after breaking down showing level of blue stain July 2022. Source: FCNSW
