Tumut Management Area Fire Salvage

2019–20

Final Report (*for public release*)

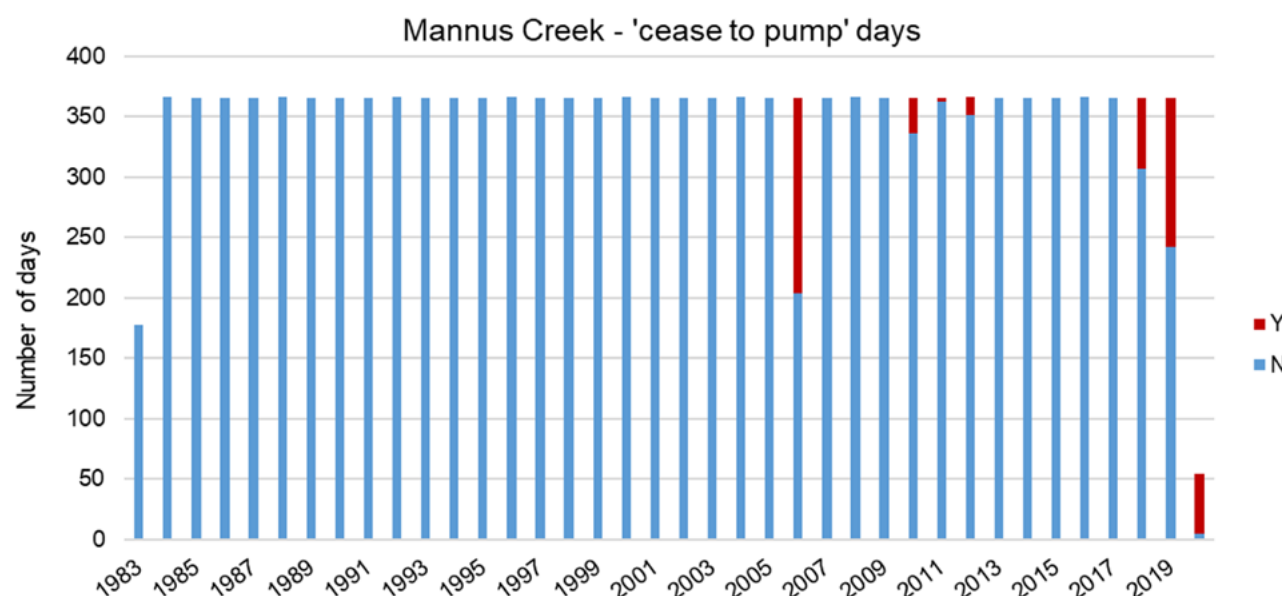
Figure 5-1: Analysis of days where a cease-to-pump order existed on Mannus Creek 1983-2020. Source BOM-Mannus Ck (401029)

- Secure water is unlikely to be available from any other source. Options were explored within Green Hills and Bago, and at Mannus Lake. Most unregulated water sources run the risk of 'cease-to-pump' provisions being applied during dry periods. If logs were unable to be watered for more than a few days, it is likely severe degradation would rapidly occur in warm weather.

An example of the risks in establishing a log storage area adjacent to Mannus Lake is demonstrated below. The red columns indicate the number of days in each calendar year that cease-to-pump orders would apply for the Mannus Creek, based on the water flow at the Glenroy Rd gauge. It shows that from 1983 to 2005, pumping was permissible **all year**, including the drought conditions of 2002-03. An extended cease to pump period applied in 2006, as well as shorter periods in 2010-2012. However, during 2018, 2019 and 2020, pumping would not have been permitted for at least three months in each year.

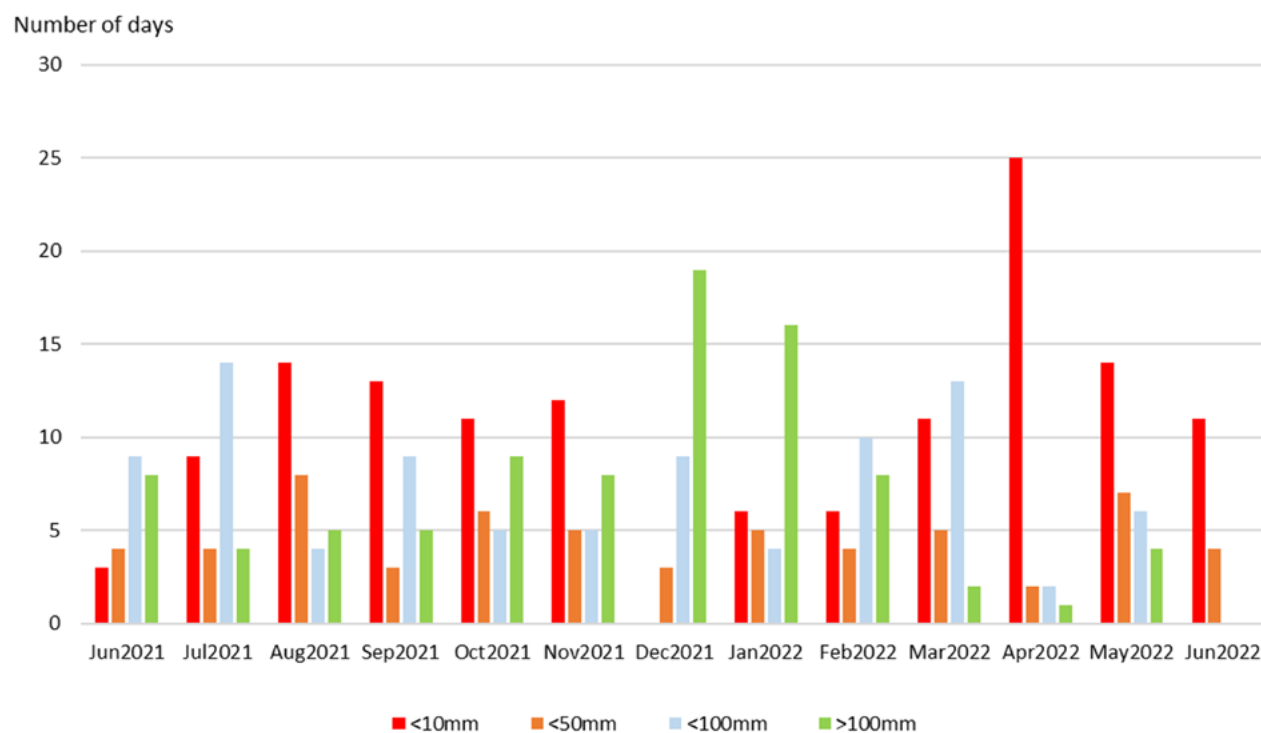
Figure 6-4: Number of days per month (by daily applied water category – mm/day). Source: FCNSW

These issues became more prevalent towards the latter part of the trial period as equipment aged and water became potentially stagnant with a higher level of contamination. Full time monitoring was not available or practical for the trial. Under a full operational storage system both automatic and on-site monitoring systems would be a fundamental requirement due to the risks associated with sprinkler failure.

The gauge obviously did not differentiate between natural rainfall and applied water. According to the Batlow Post Office weather station, the region received 2135mm of rain during the 550 days of the trial period. On average this was just 3.9mm compared to 67mm measured through the tipping gauge.

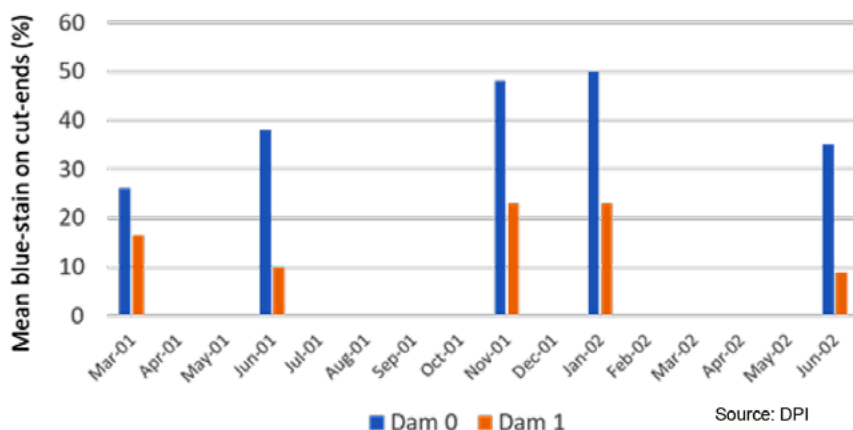
Figure 6-5: Blue stain observed from logs in storage dam (Dam 1) relative to a control sample (Dam 0). Source: DPI

There was no discernible difference between the occurrence of Ips in the watered logs and the control. Although the dataset needs to be treated with caution as the assessment team were not able to sample logs easily from within the watered stockpile, watered logs clearly provided some protection against the ingress of bluestain, from the data available as shown in Figure 6-6.

After the logs had been stored for 16 months, the site was inspected, to cut disks and conduct resi sampling. Despite the black outwards appearance of the logs the quality of the internal timber remained largely white and did not have any obvious decay. The logs in the first half metre or so to the surface had started to get blue stain as they were most exposed to the elements and moisture variation. A disk cut from a log one metre down in the middle of the stack had no obvious stain.

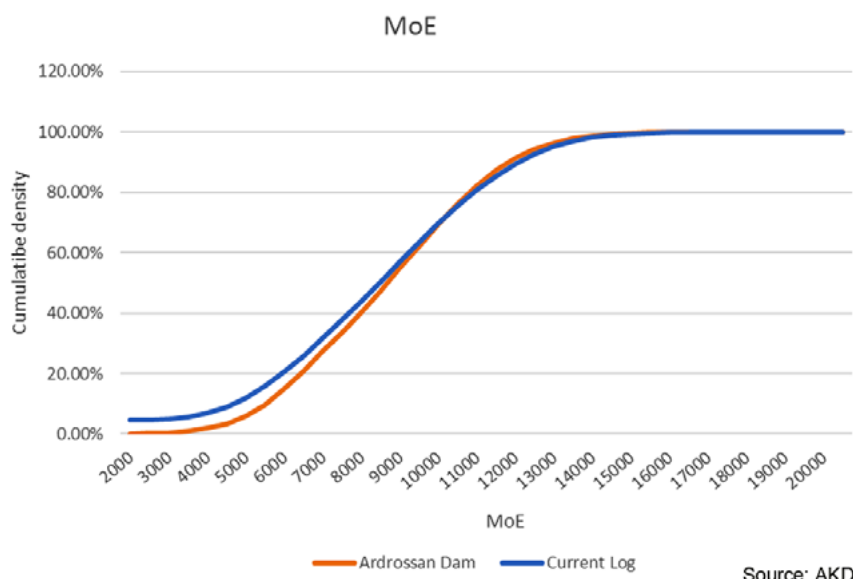
Figure 6-6: Cumulative distribution MoE (GPa) of boards from trial compared to green logs. Source: AKD

The following chart depicts the MoE of sawn boards compared to the routine logs being processed at the same time. Whilst the general observation is a lower MoE was achieved, it was considered very reasonable in terms of structural grade recovery. The data must be treated with caution as other factors are likely to be influencing the results such as genetic stock and site factors.

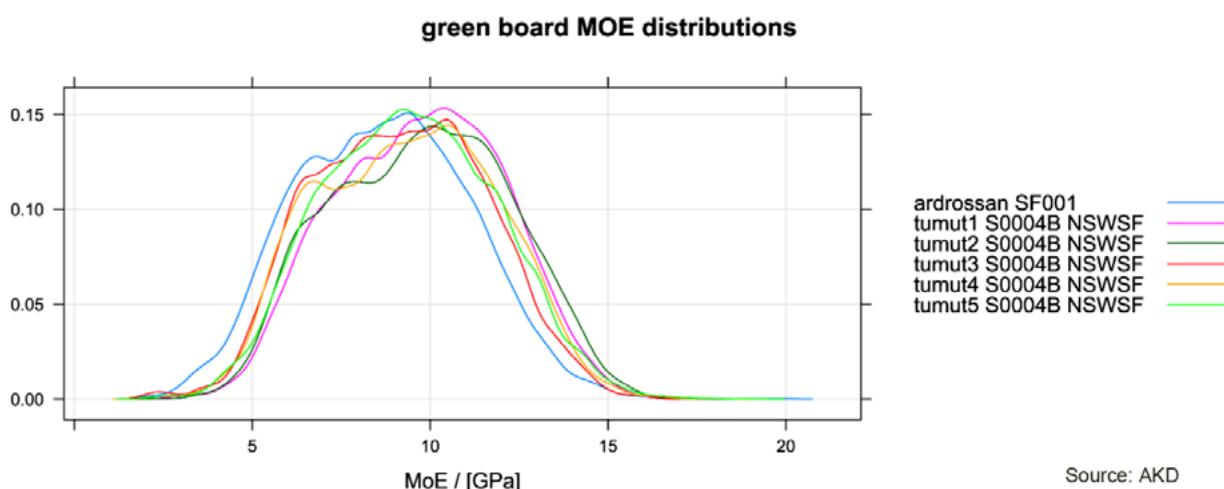
Figure 6-7: MoE distributions of boards from trial compared to 'routine' salvage. Source: AKD

The results from the trial were also compared to batches processed in 2020 from 'routine' salvage. This demonstrated that whilst the distribution was clearly lower, it fell within the range considered acceptable for structural grades.

Both density and MoE from the stored logs proved to be very similar to the run-of-bush being processed at the same time.
